NASA CR-112119-2

**EVALUATION OF COATED COLUMBIUM ALLOY
HEAT SHIELDS FOR SPACE SHUTTLE
THERMAL PROTECTION SYSTEM APPLICATION**

PHASE II ♦ SUBSIZE HEAT SHIELD AND SMALL SIZE TPS EVALUATION

Prepared by
CONVAIR AEROSPACE DIVISION OF GENERAL DYNAMICS
San Diego, California

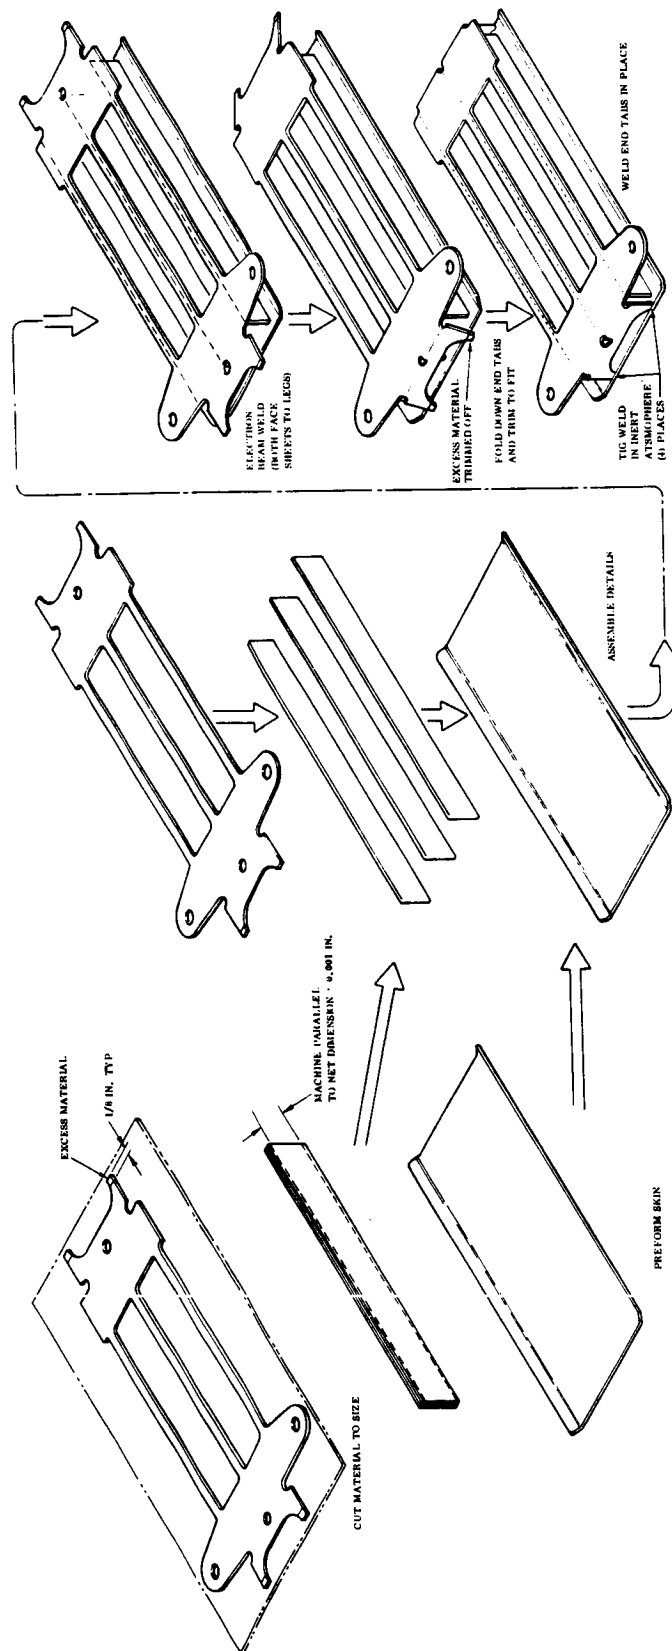
Figure 4-5. Subsize Tee-Stiffened Panel Fabrication Sequence

The tee-stiffened panel (Figures 4-2 and 4-4) is a welded sheet metal structure that requires several more manufacturing operations than does the corrugated panel. However, the structure employs reasonably normal sheet metal fabrication. Only the edge and corner preparation and the use of electron beam welding differentiates this structure from other common sheet metal structures. The requirements for edge and corner preparation for coating are the same as for the corrugated panel, although there are many more surfaces to be prepared on this panel. The edge preparation noted in Figure 4-4 is sequenced to be done when the operation can be the most readily performed during assembly (i.e., in detail or at some stage of assembly).

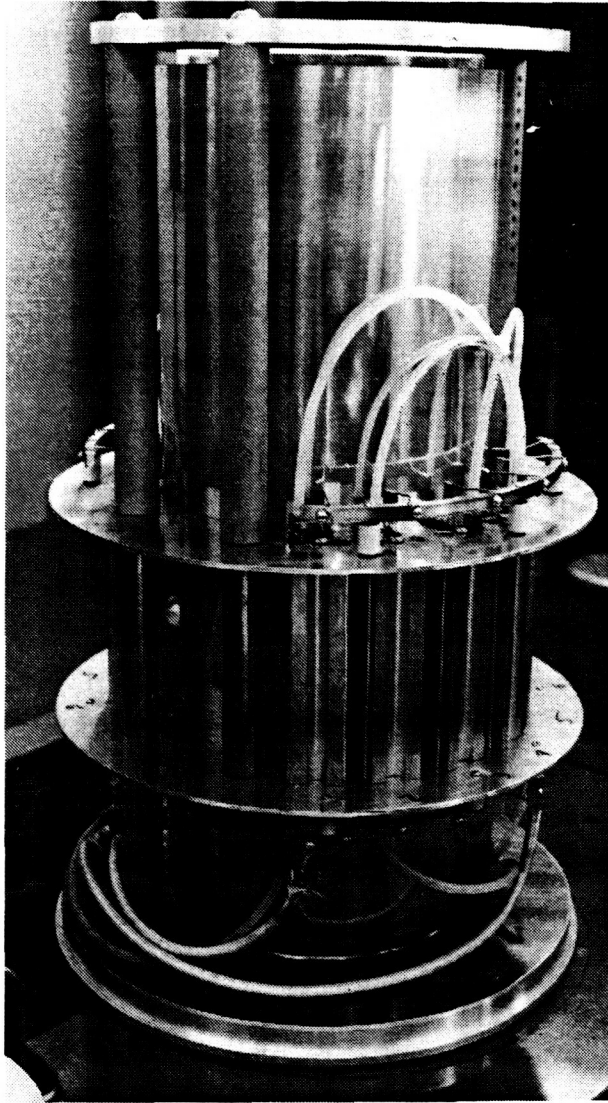
Figure 5-3. Quartz Lamp Furnace Chamber
(Photo 122031B)

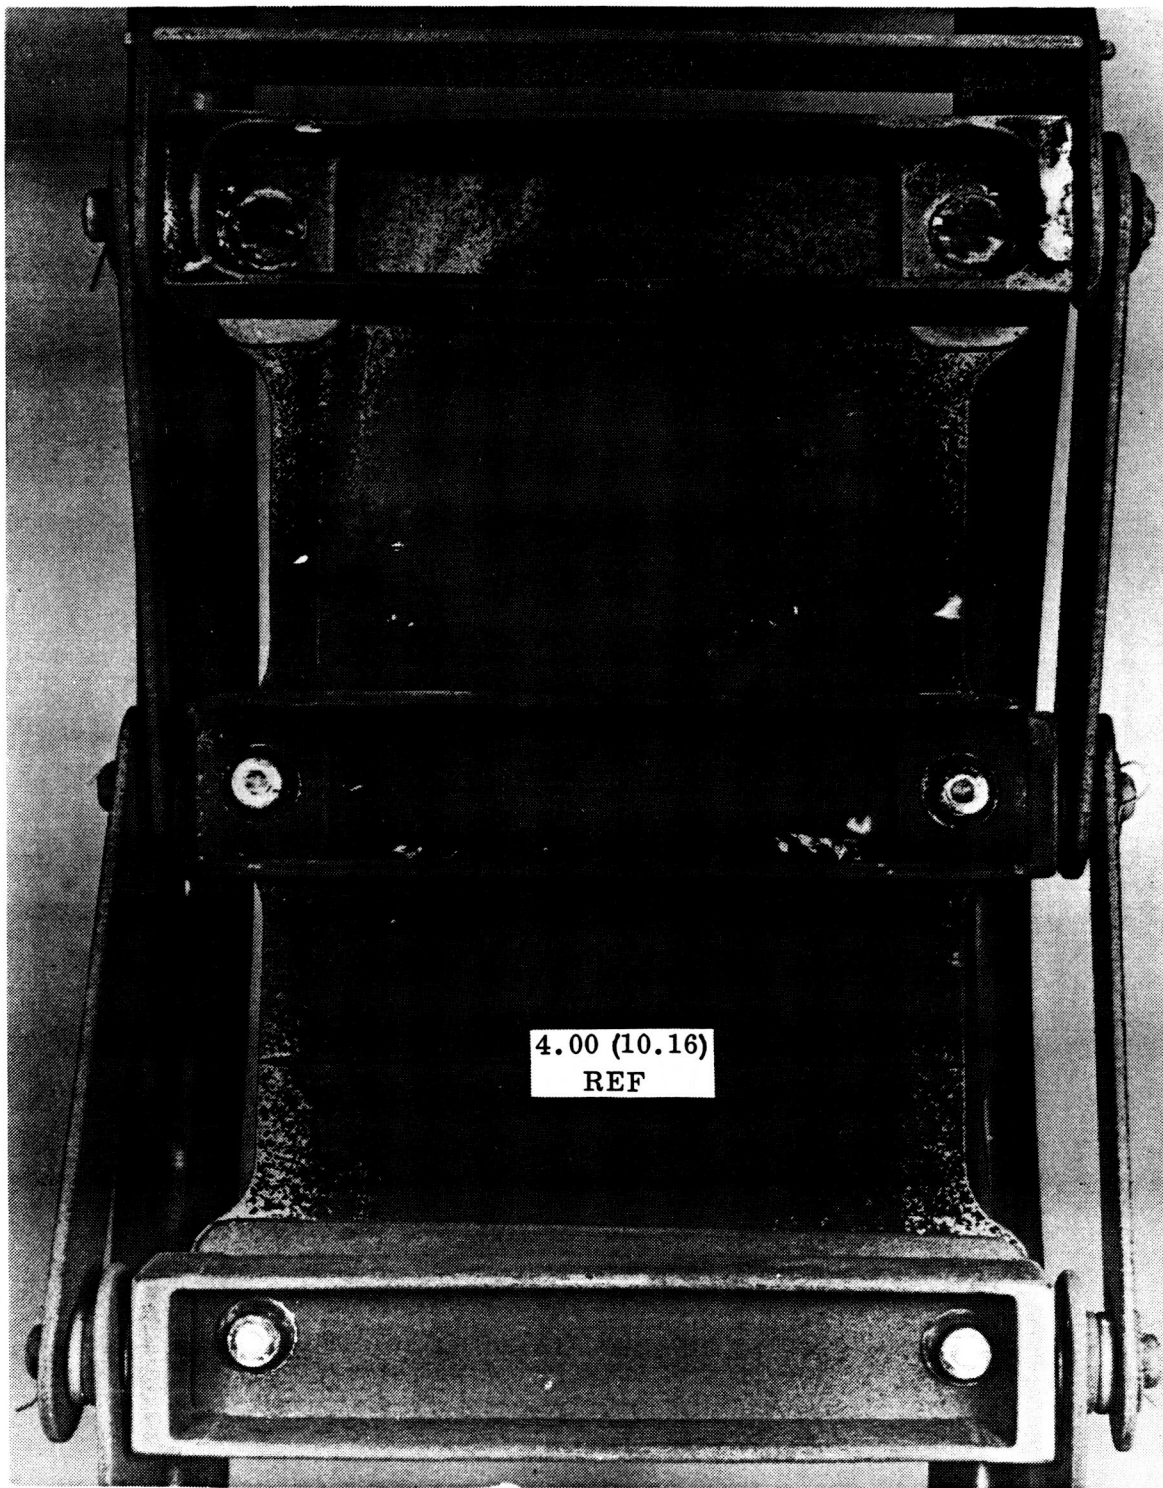
Figure 5-10. Front View of Panel YSC-3 After 20 Flight Simulation Cycles (Photo 121504B)

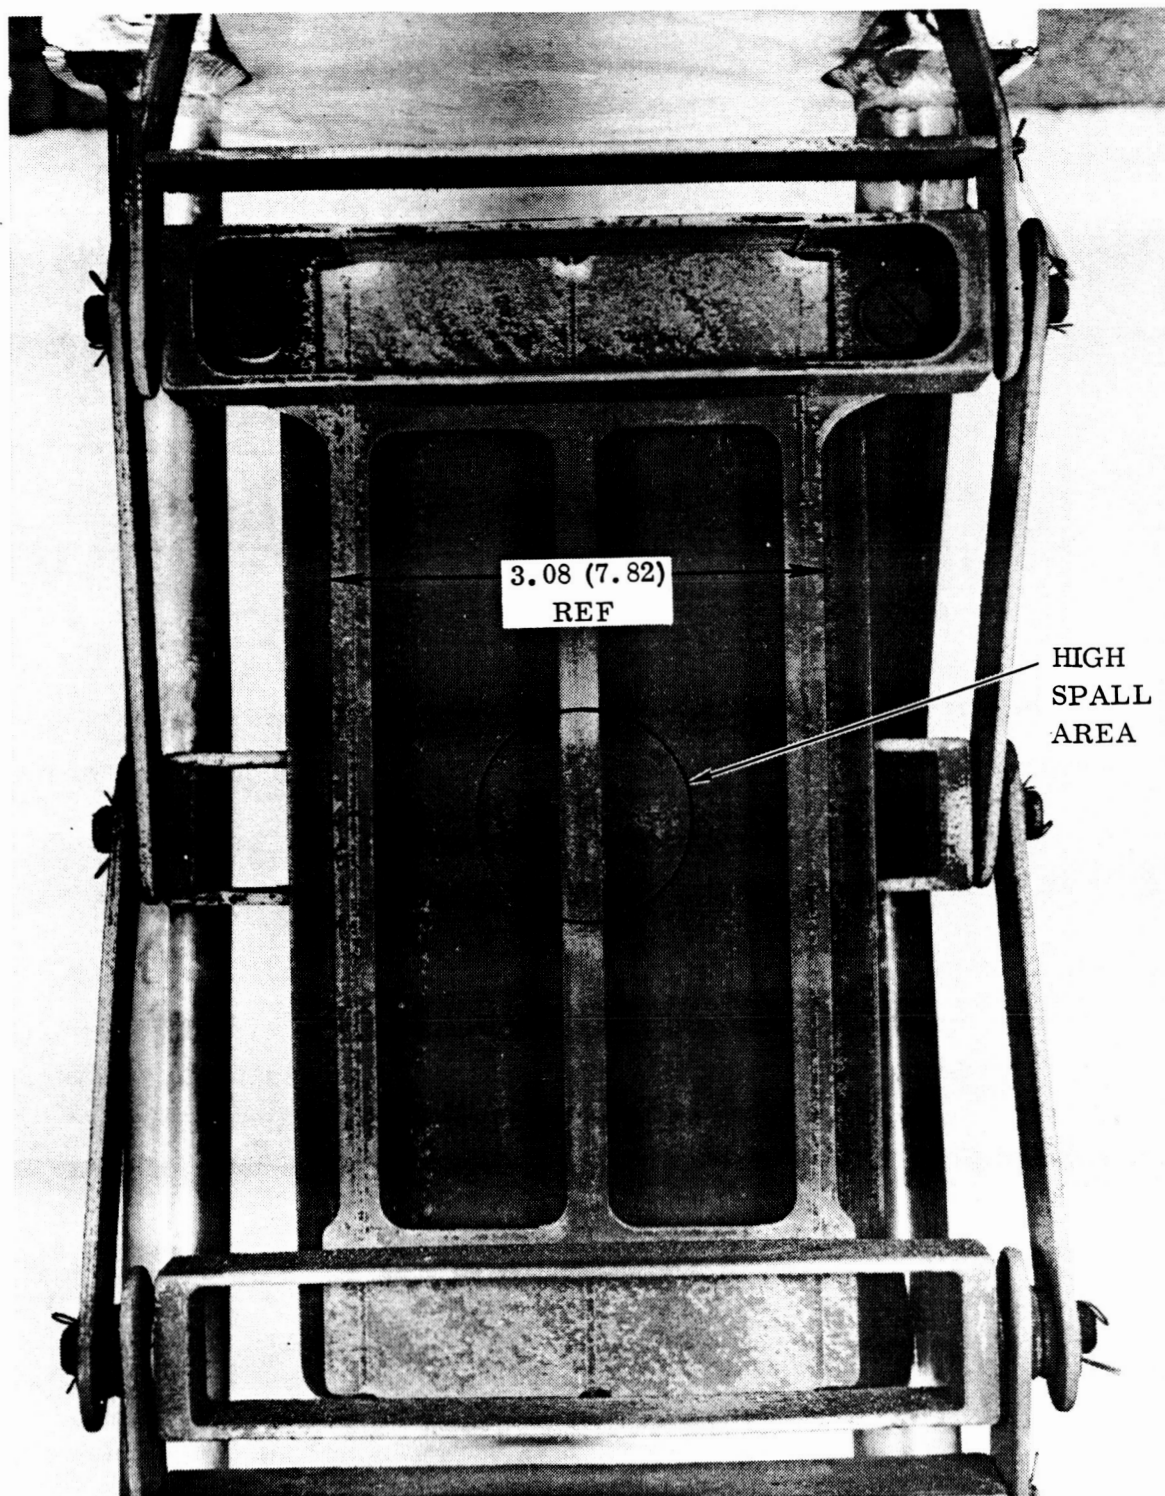
Figure 5-21. Beginning of Edge Attack and Increased Surface Spall on Panel YST-3 After 59 Flight Simulation Cycles (Photo 122944B)

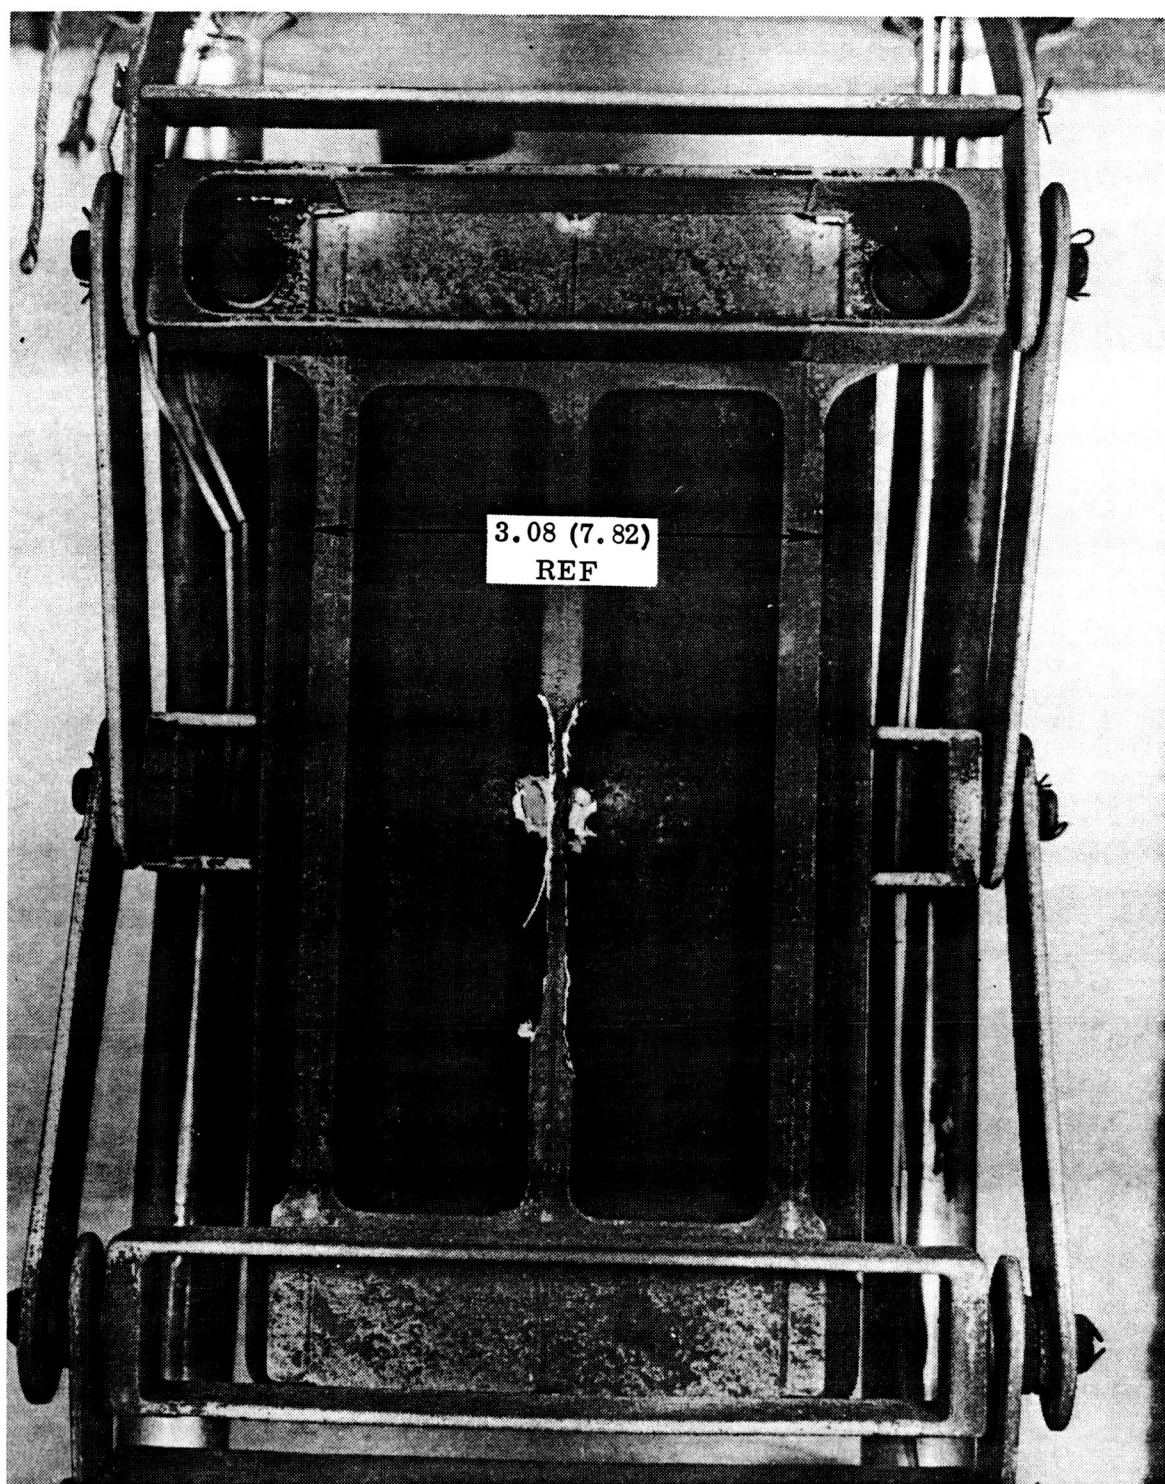
Figure 5-22. Skin Failure Extending Through Panel YST-3 After 83 Flight Simulation Cycles (Photo 123003B)

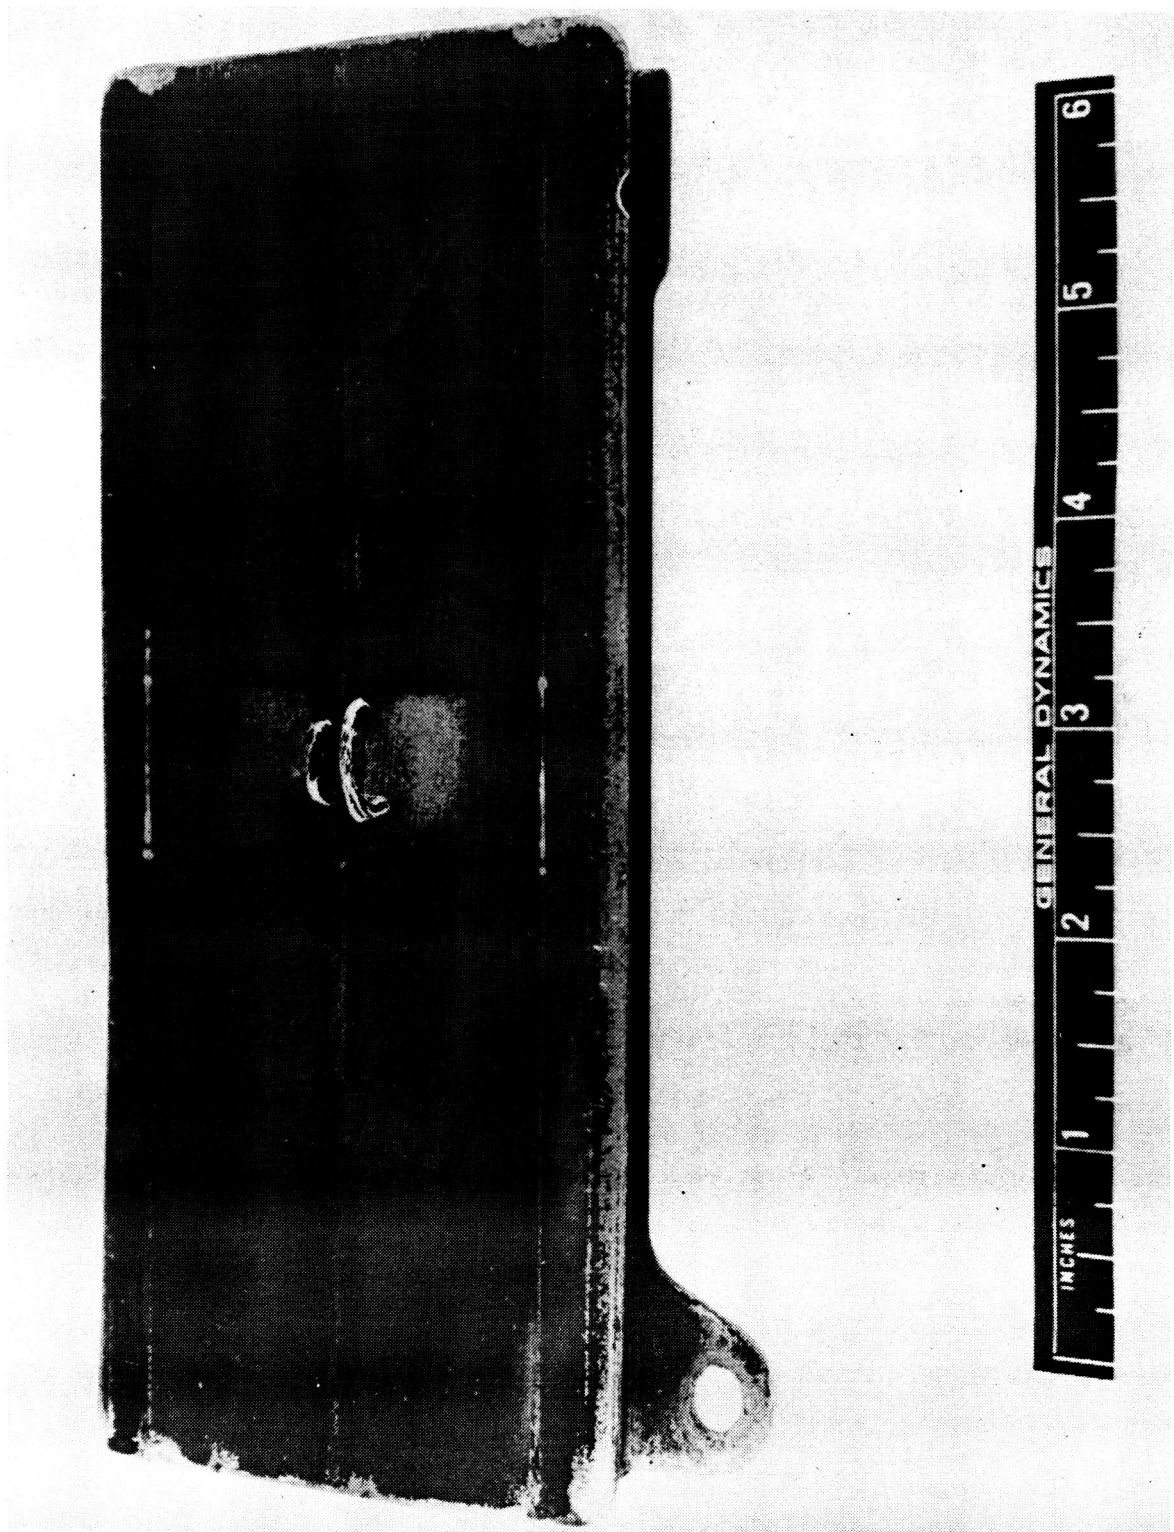
Figure 5-23. Front View of Panel YSC-3 After 100 Flight Simulation Cycles (Photo 123217B)

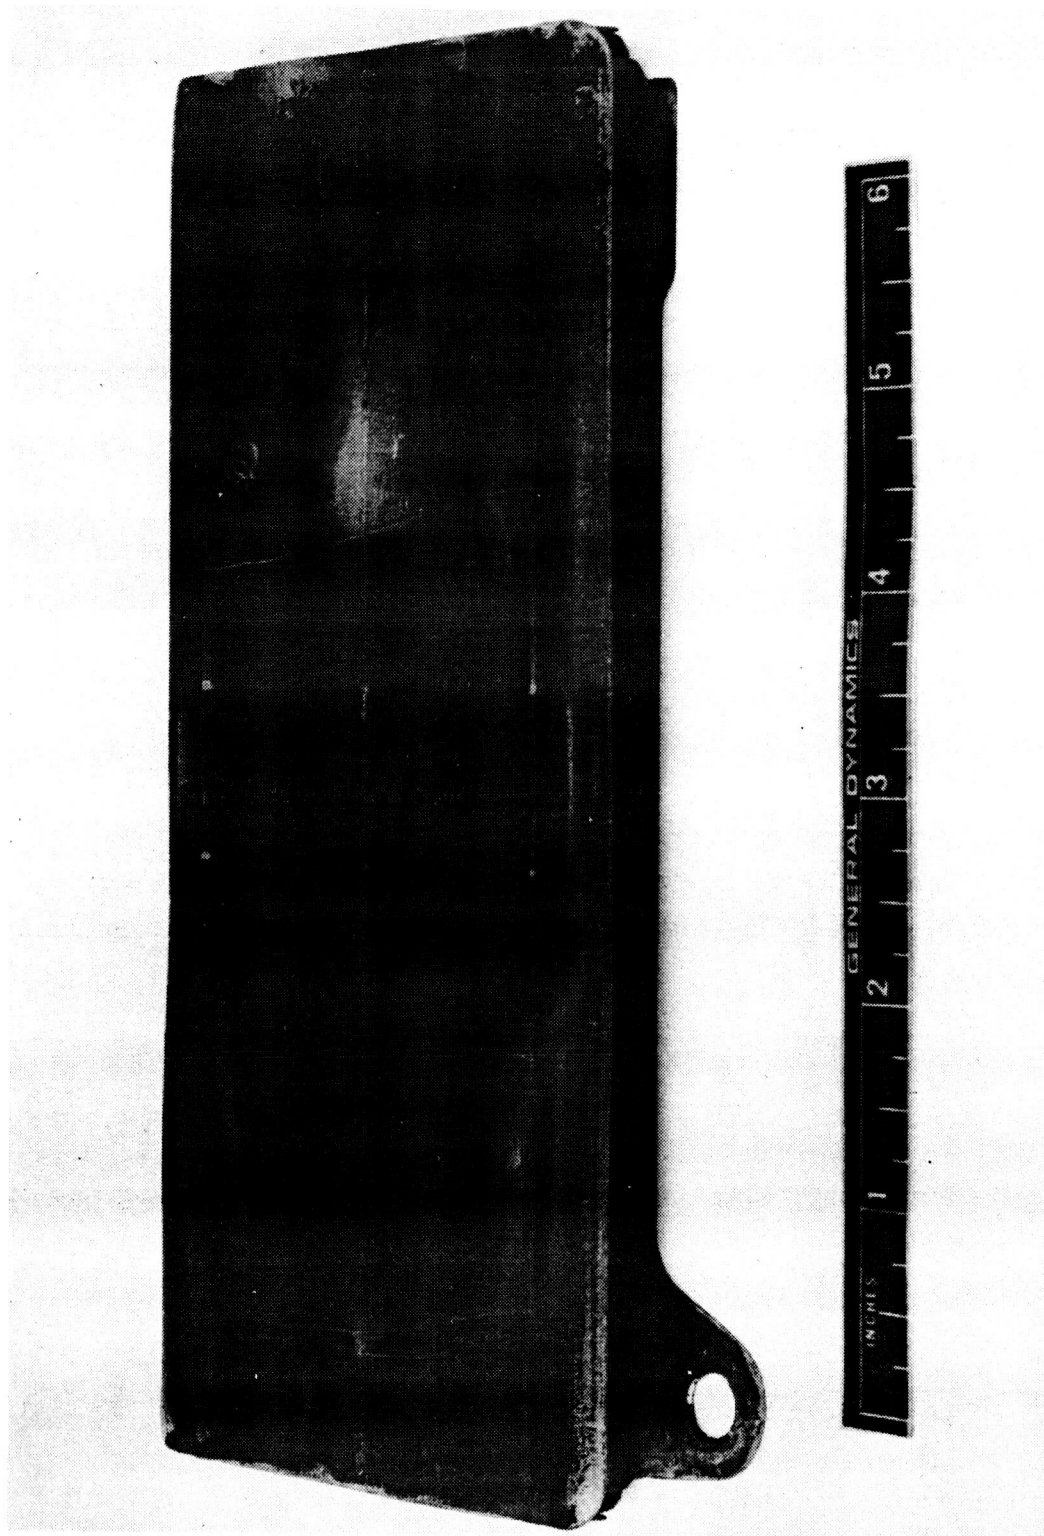
Figure 5-26. Front View of Panel YST-4 After 64 Flight Simulation Cycles (Photo 123475B)

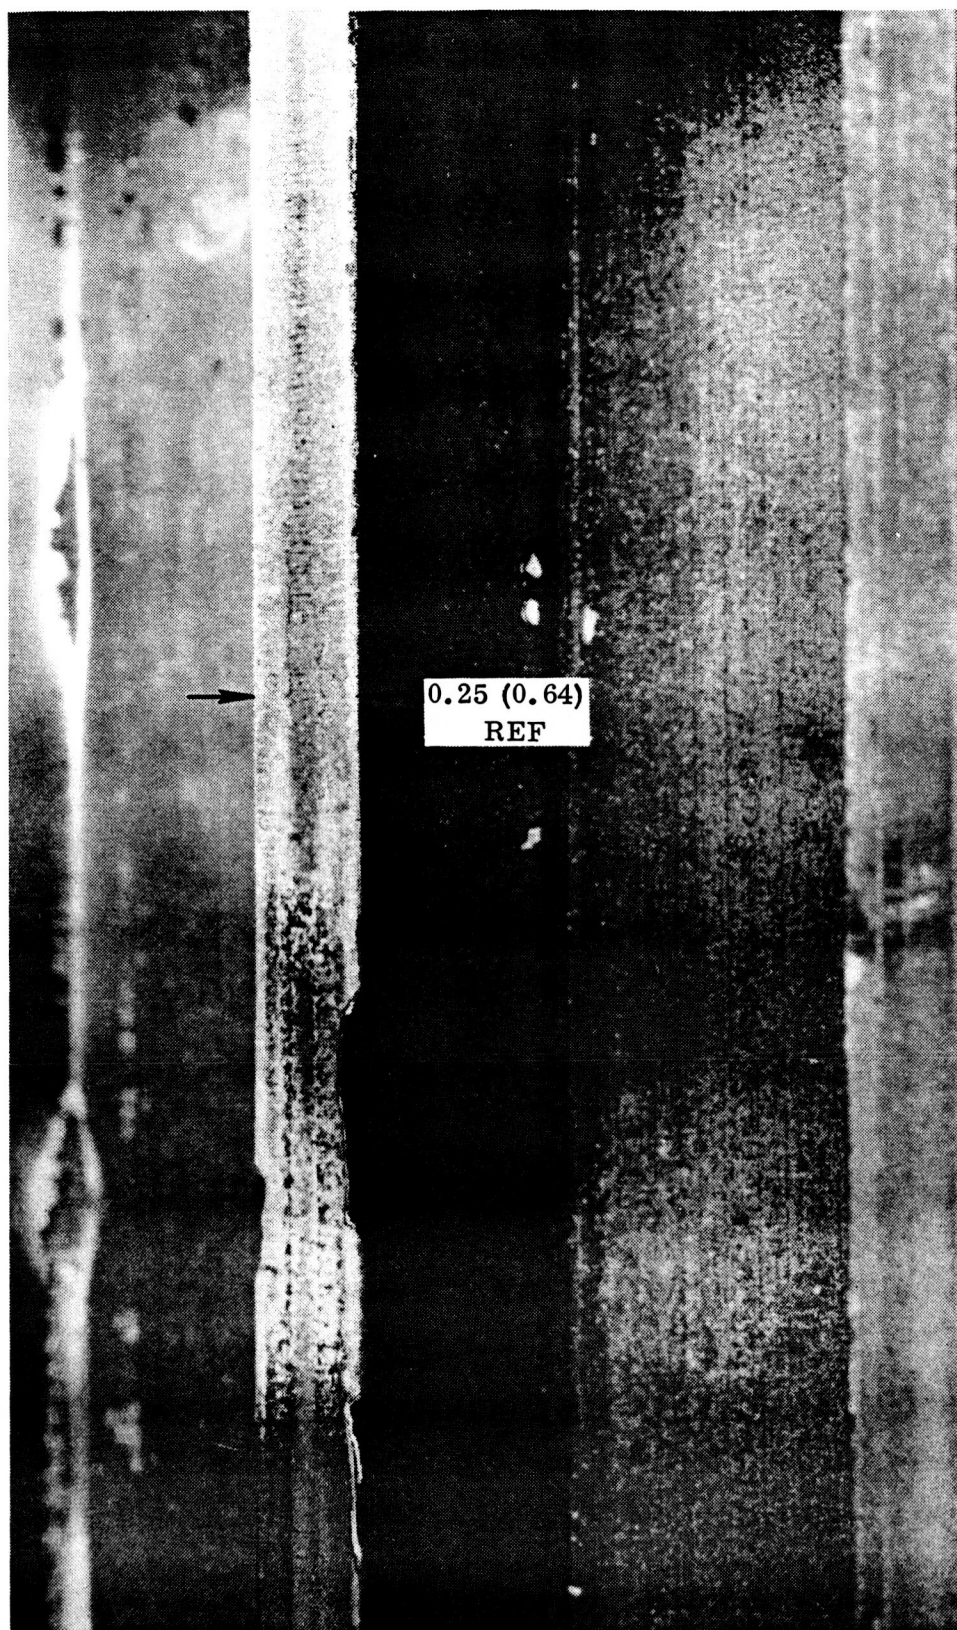
Figure 5-28. Close-up View of Damaged Areas of Panel YST-4
After 64 Flight Simulation Cycles (Photo 123477B)

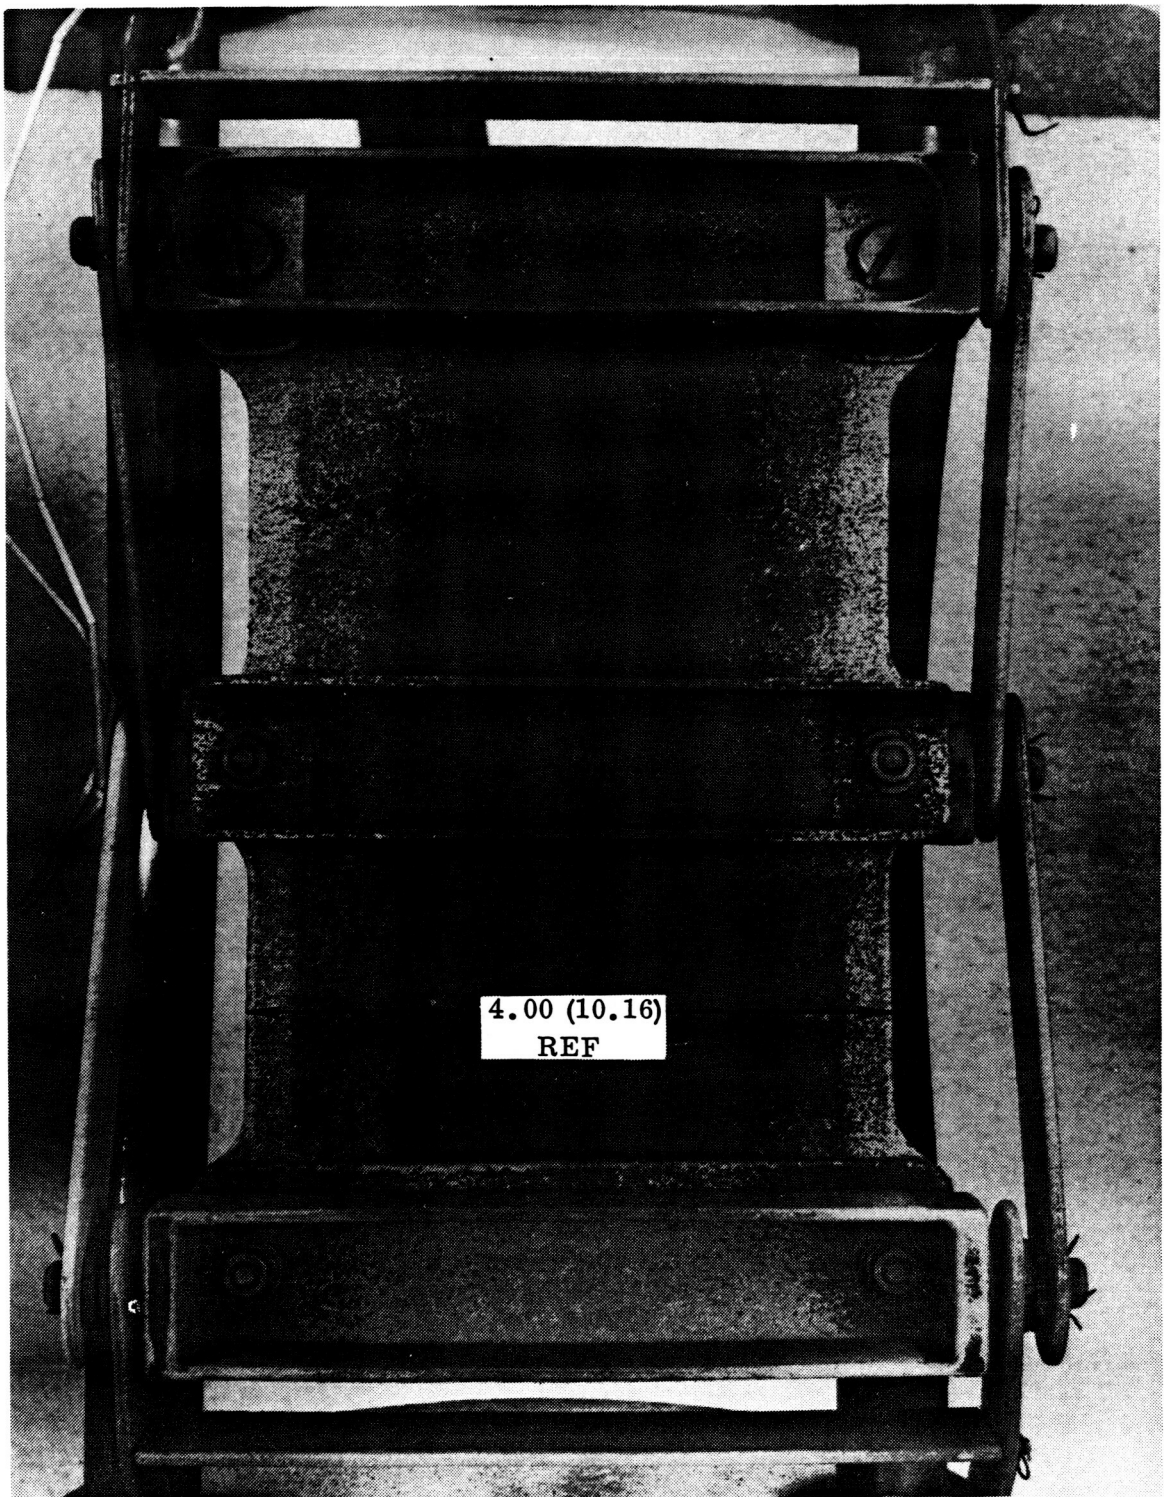
Figure 5-29. Front View of Panel BSC-1 After Nine Flight Simulation Cycles (Photo 124718B)

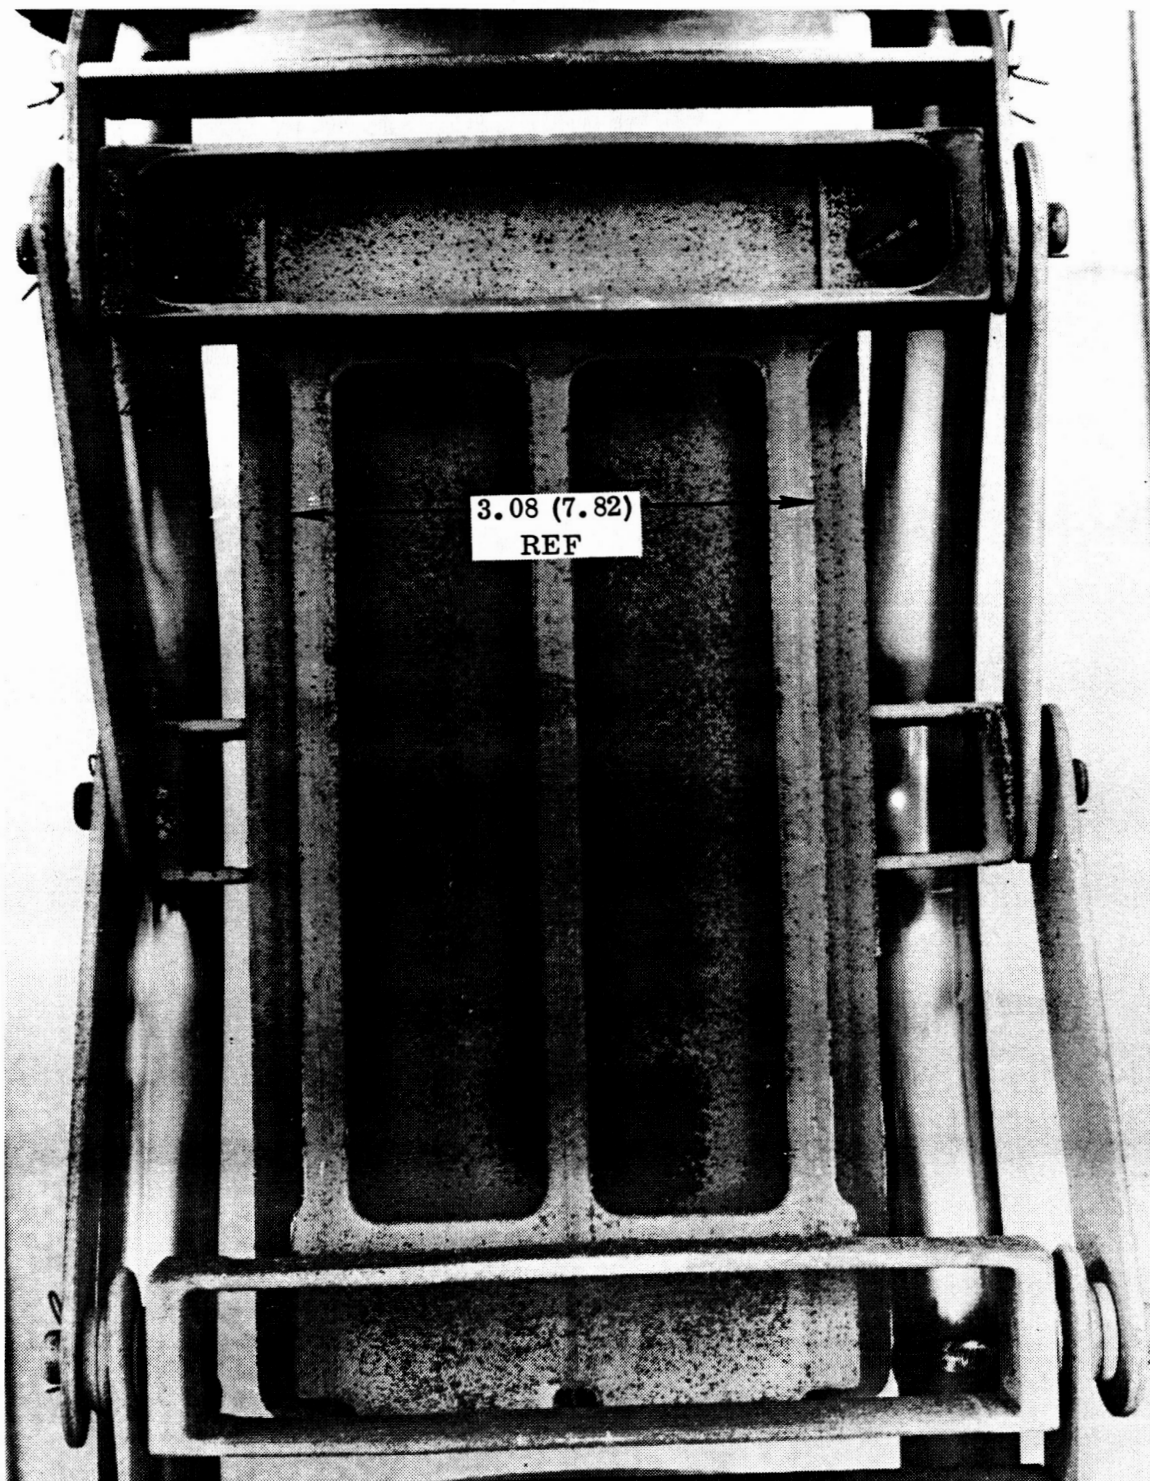
Figure 5-37. Front View of Panel BST-4 After 20 Flight Simulation Cycles (Photo 122485B)

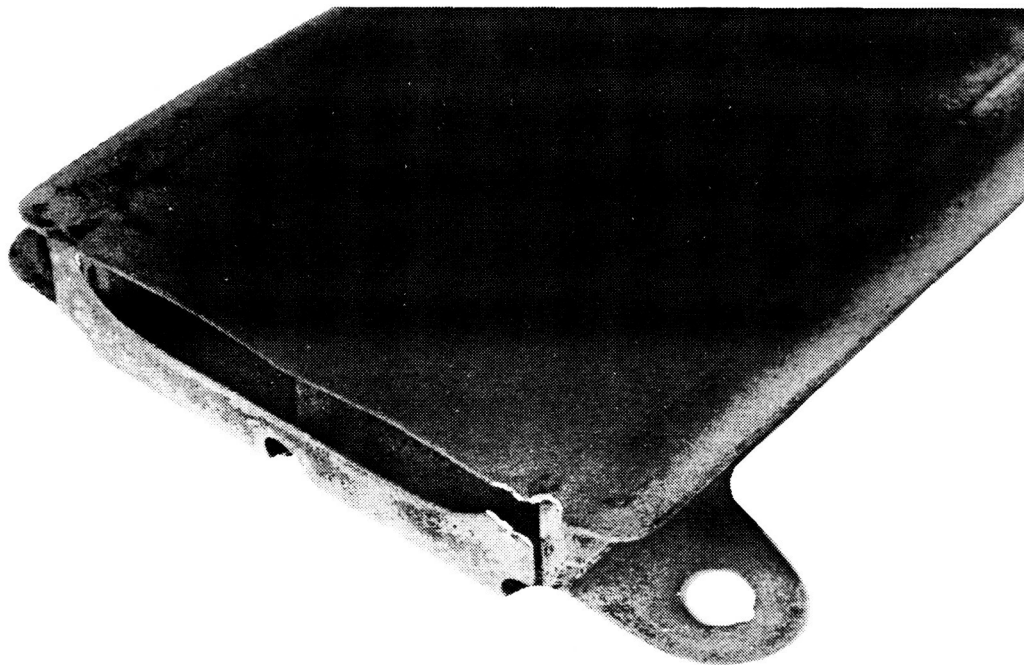
Figure 5-44. Coating Damage and Erosion of Panel BST-3 After 100 Flight Simulation Cycles (Photo 122527B)

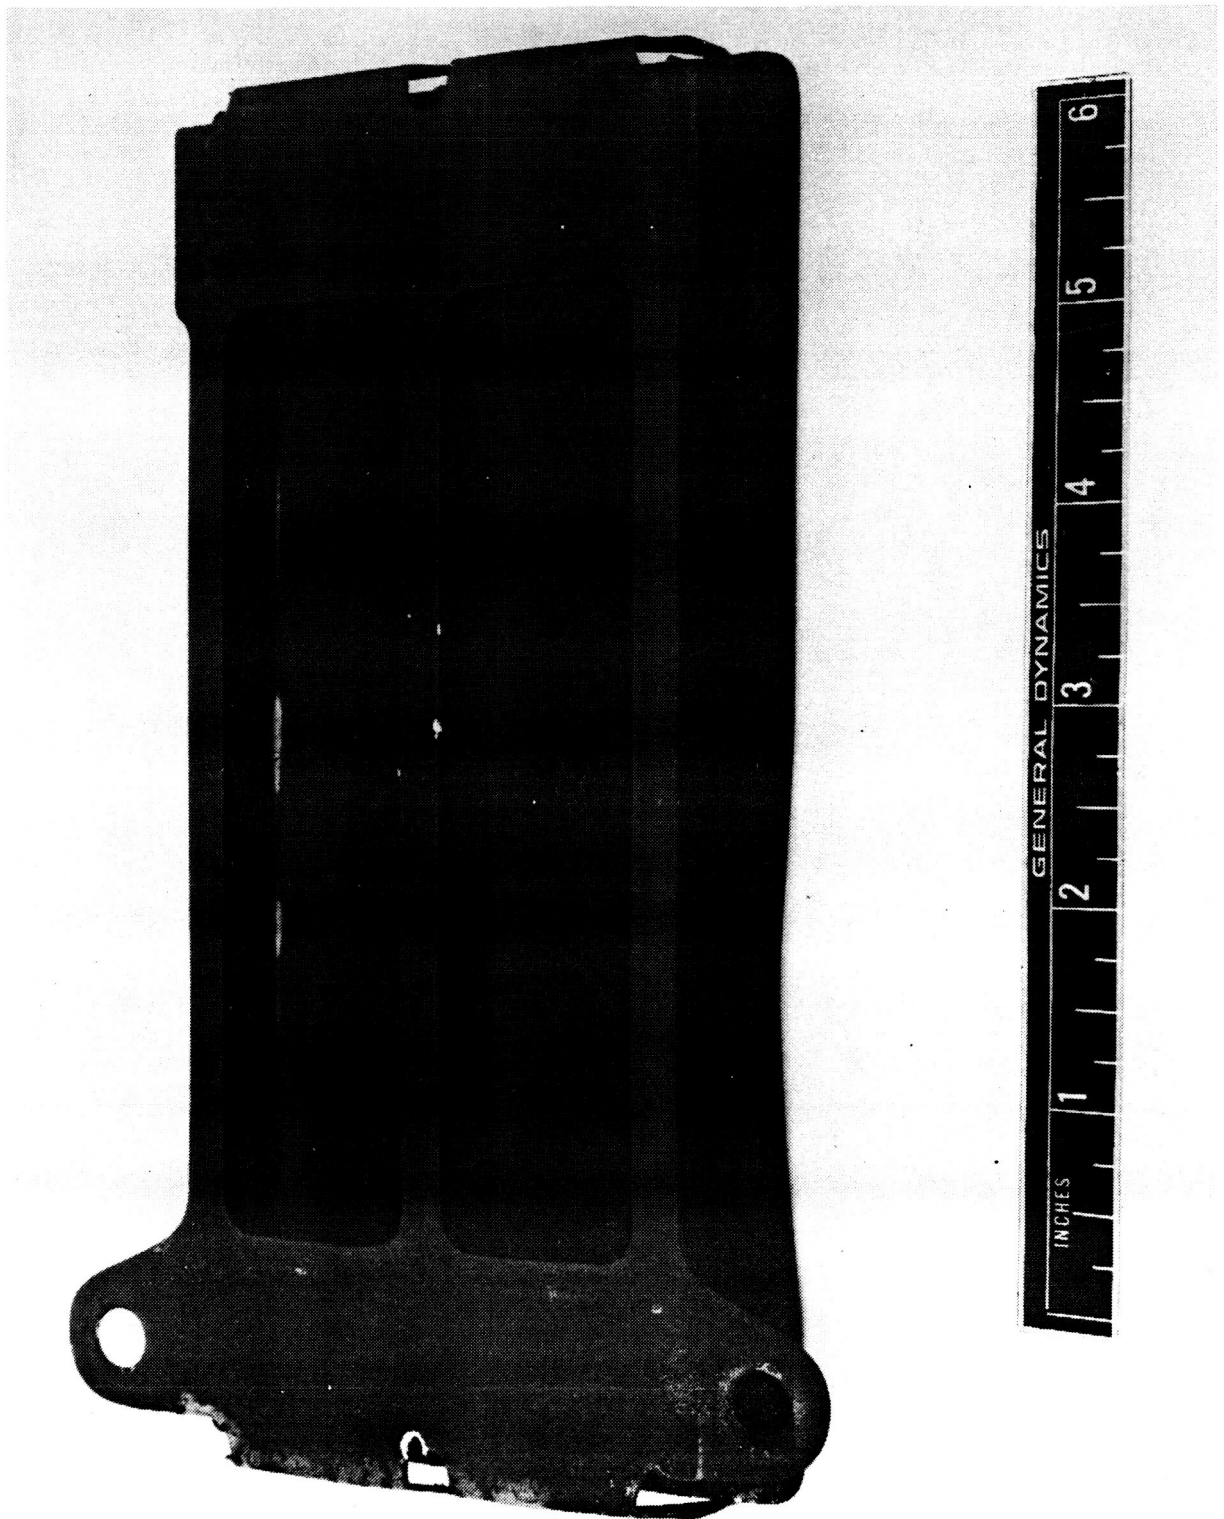
Figure 5-45. Front View of Panel BST-1 After 100 Flight Simulation Cycles (Photo 123799B)

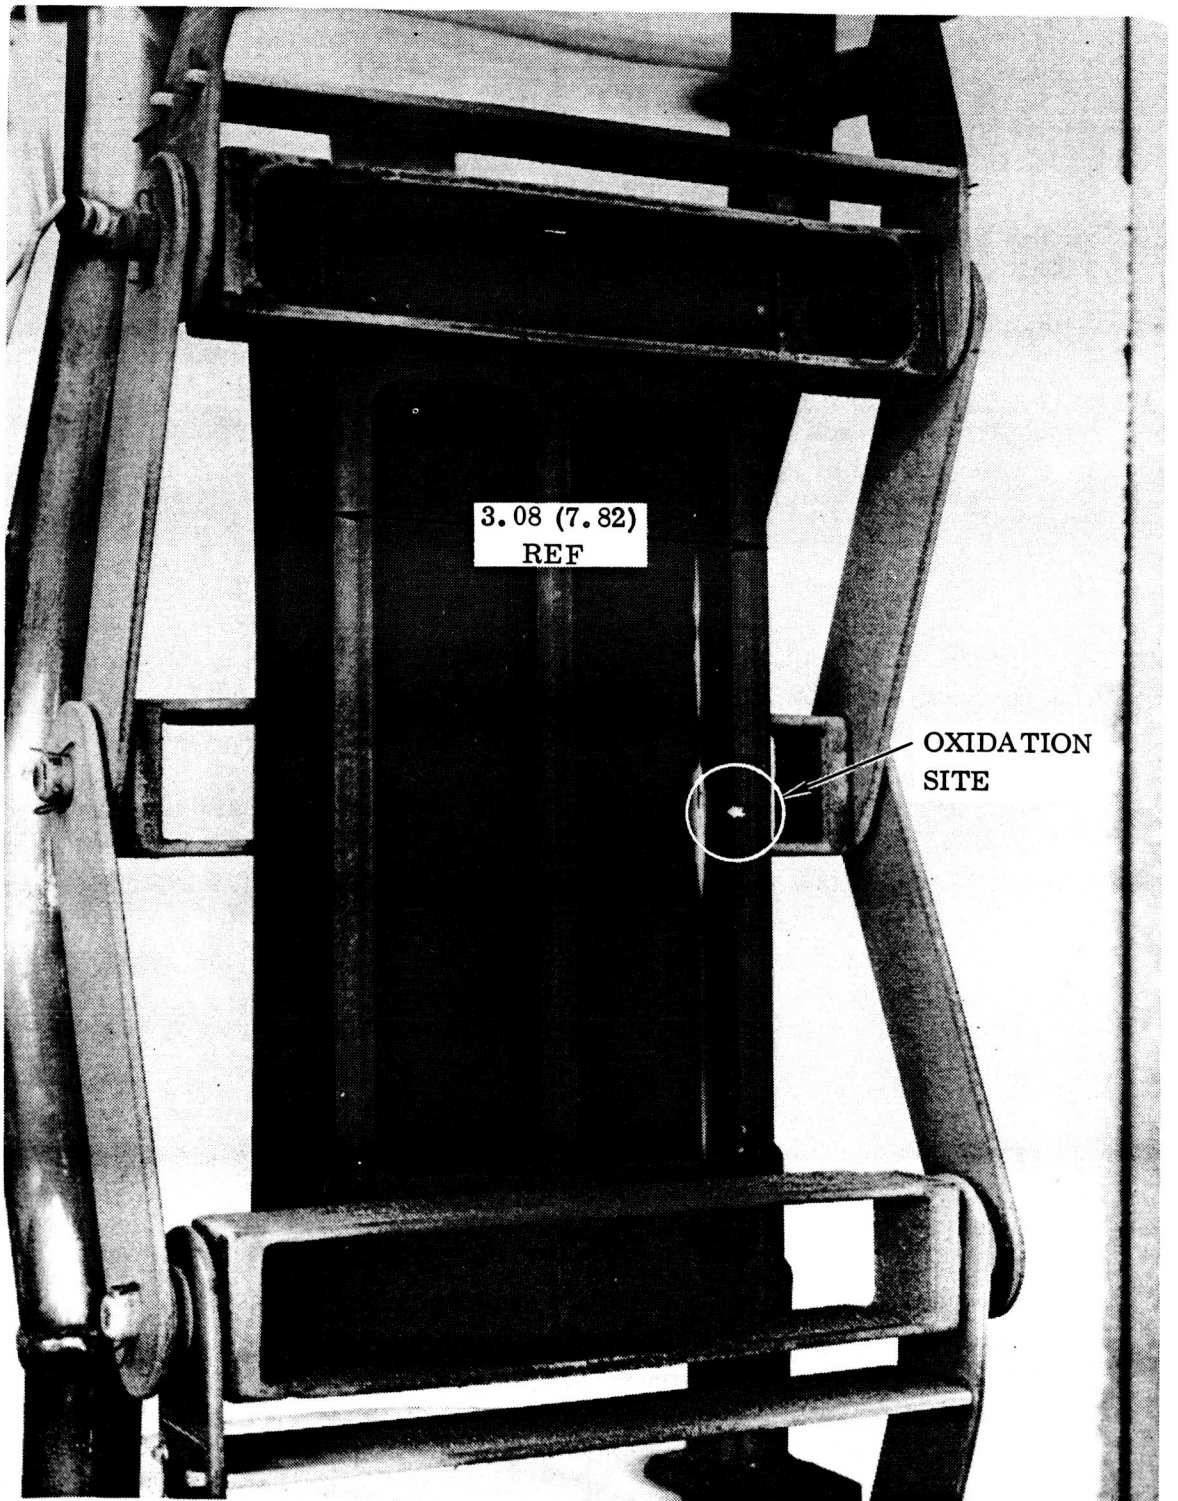
Figure 5-48. Panel BST-2 Oxidation Site at 66 Flight Simulation Cycles Before Coating Repair (Photo 121540B)

At the end of 83 and 93 cycles on panel BST-2, "field" repairs were made to the localized failure sites using a modification of a technique developed by McDonnell Douglas Astronautics Company - East. The procedure was to remove the yellow oxide and cover the exposed area with a slurry composed of 60 weight percent Pyrex frit, 30 weight percent alumina, and 10 weight percent boron mixed with Microbrazing binder. For expediency, the repair coating was not given the normal firing at 2100° F (1422° K) but was used "as applied" with the flight simulation cycle providing the necessary firing conditions. These repairs were about 50% effective in preventing further substrate oxidation during the remaining cycles. The effectiveness could be greatly increased, however, with better preparation of the failure site (e. g., grit blasting) to remove all

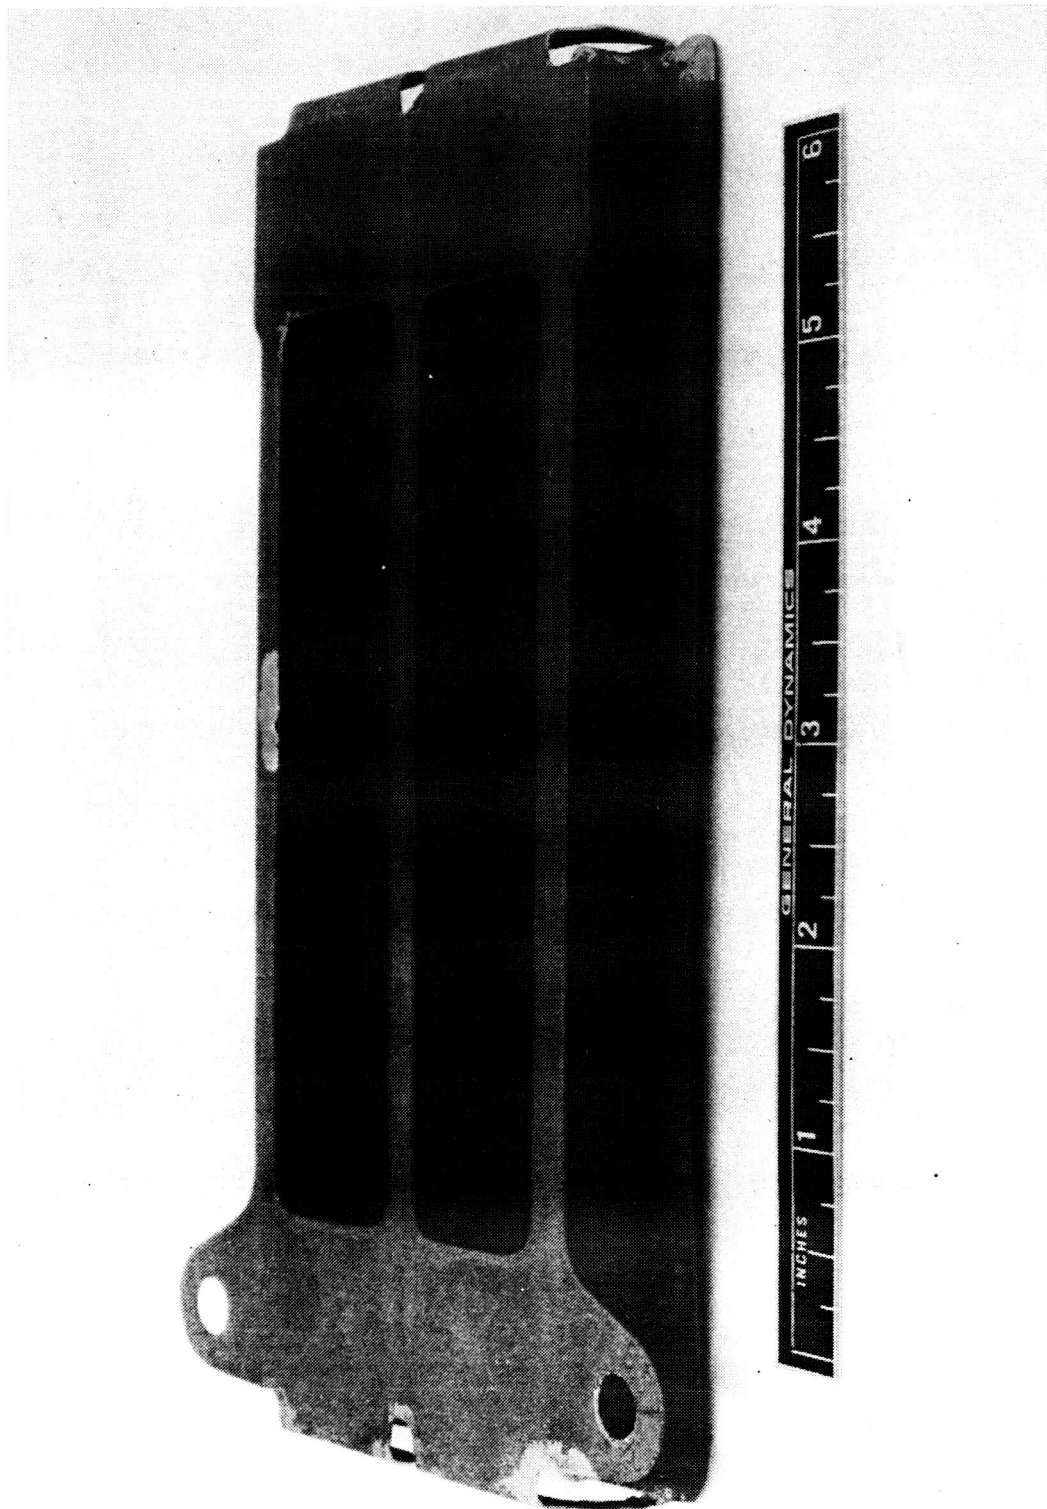
Figure 5-49. Panel BST-2 at 66 Flight Simulation Cycles
After Coating Repair (Photo 125205B)
